## SAFETY FLYER TO SEA ANGLERS

The sinking of the recreational motor cruiser *James 2* and loss of 3 lives following its collision with the fishing vessel *Vertrouwen* 1.6 miles south of Shoreham-by-Sea on 6 August 2017

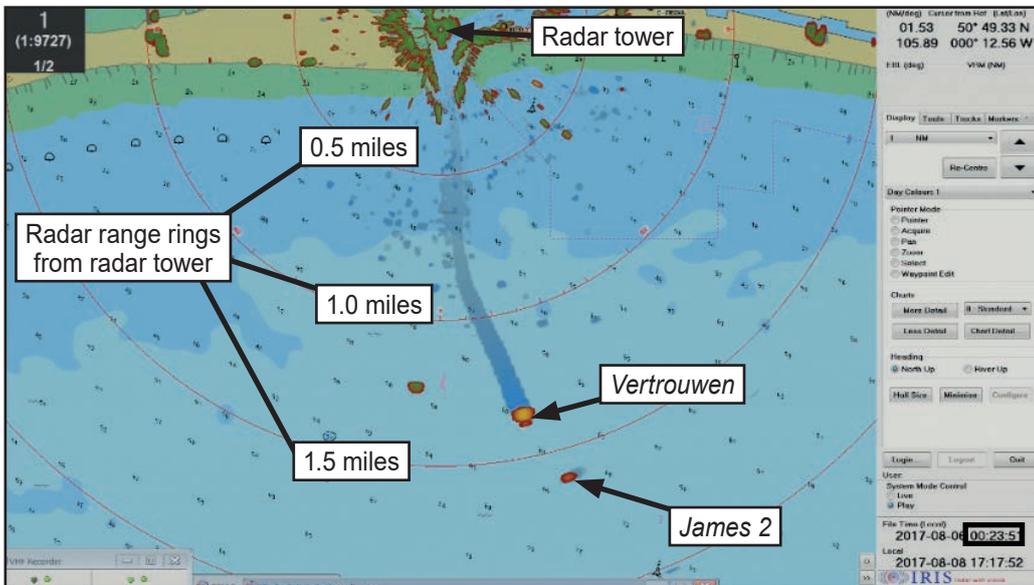
Figure 1: Scene of accident as captured by Shoreham Harbour radar

At 0026 on 6 August 2017, the 5.64m recreational motor cruiser *James 2* and the 26.24m commercial fishing vessel *Vertrouwen* collided in Sussex Bay, 1.6 miles south-east of Shoreham harbour (Figure 1). Both vessels were undamaged by the impact but *James 2* was swamped by

The collision occurred because *Vertrouwen's* lone watchkeeper did not see *James 2* and, by the time the sea anglers realised the danger they were in, they were unable to get out of the way. *James 2* sank because it did not have the internal subdivision or built-in buoyancy necessary to keep it afloat in the flooded condition. The three sea anglers drowned because they were not wearing personal flotation devices (PFDs) (lifejackets or buoyancy aids) and were unable to raise the alarm; the fourth sea angler was extremely fortunate to have survived. The investigation concluded that:

1. Had the sea anglers on board *James 2* been keeping a lookout, they might have spotted the danger posed by *Vertrouwen* much earlier and been able to take effective evasive action. The keeping of a good lookout and assessing the risk of collision is a vital part of safe boat operation.

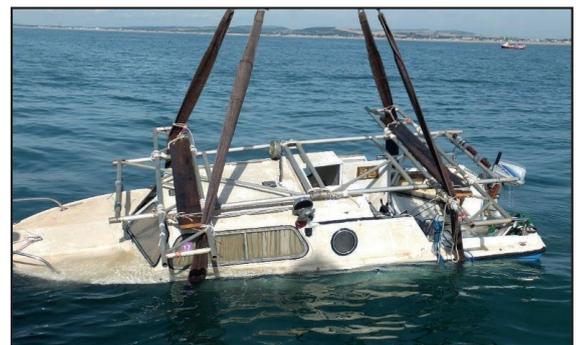
*Vertrouwen's* wash and sank (Figure 2). Three of the men on board the motor cruiser drowned; a fourth was rescued from the water 5 hours later by a passing fishing vessel. *James 2* was drifting with the wind and tide while the four men on board were rod fishing for mackerel; *Vertrouwen* had just left port and was on passage to Grimsby.

Figure 2: *James 2* being recovered

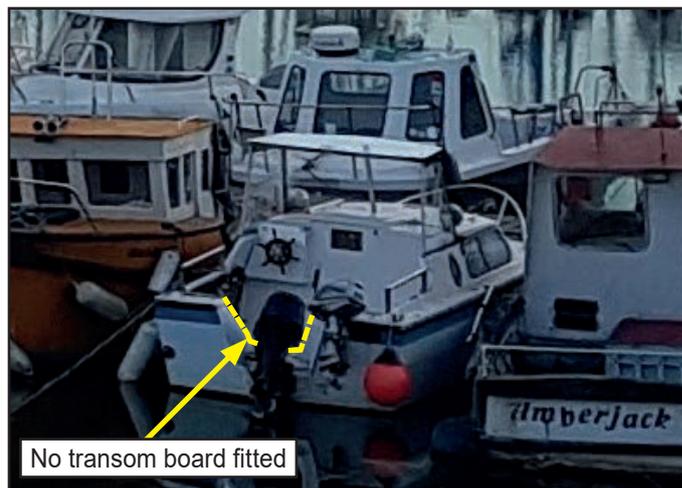
- Neither vessel was maintaining a proper lookout: the lone watchkeeper on board *Vertrouwen* was distracted immediately prior to and during the collision; the sea anglers had been drinking and were focused on enjoying a social evening night fishing, and they therefore did not keep an effective lookout.
- *James 2* did not have the navigation lights required for a vessel of its type and size and might not have been visible from *Vertrouwen's* wheelhouse.
- *James 2* and the four sea anglers were ill-prepared for going to sea:
  - The motor cruiser had inadequate freeboard in way of the outboard motor, and had no means of pumping out flood water (Figure 3).

**Figure 3:** *James 2* - showing low freeboard in way of the outboard motor

3. *James 2* had a section cut out of its transom to enable easy access to the outboard motor, and for it to be tilted out of the water when not in use. This reduced the boat's freeboard and made it much more susceptible to flooding. A board should have been fitted to the inboard side of the transom to increase the freeboard and prevent water ingress. Owners should ensure that their boats have sufficient freeboard at all times to reduce the risk of swamping.
